An addition was proposed for the single story, steel framed structure.

Grouting Rock Fill Stabilizes Sub Surface For Redevelopment

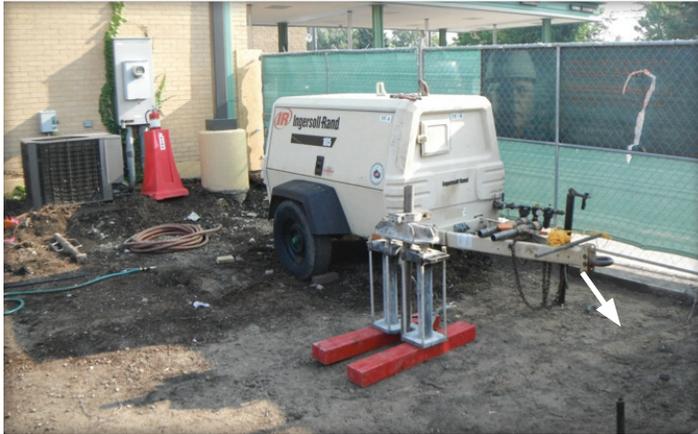
Grout Injection Pipe

The 2-inch diameter grout injection pipes were driven to the base of the stone backfill, approximately 5 feet below the design footing grade. A sacrificial driving point was inserted in the leading end of each pipe prior to driving to keep the soil from entering the pipe. The pipes were driven using a 140 pound pneumatic hammer. After driving, the pipes were raised approximately 6-inches and the sacrificial point was driven out to open the end of the pipe. The 1-inch monitoring pipes were then installed at representative locations, offset the specified distance from the center of the piers. The monitoring pipes were also raised 6-inches following driving to release the sacrificial points and allow the grout to enter the monitoring pipes. An injection pipe is pictured below. Also noted is the monitoring pipe.

Arrow denotes horizontal dispersion monitoring pipe

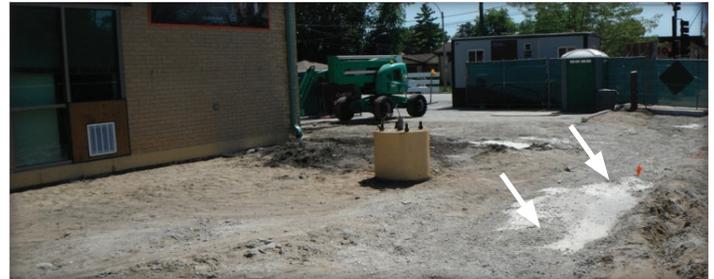
Grouting performed in close proximity to utilities

Arrows indicate approximate injection point locations and survey flags indicate utility locations

The photo above was taken hours after the project was completed, prior to final clean-up. The project was completed ahead of schedule without the removal of any spoils from the site and without damage to any of the utilities. For this project the grouting was performed prior to excavation for the pier foundations. When the grouting is performed in advance, the penetration and dispersion of the grout can be verified visually during the foundation excavation.
